PORTABLE X-RAY

BETATRON

CASE STUDIES

Construction and Civil Engineering - Bridge Inspection	03
Offshore Betatron in Association with Axess Group	05
Offshore Inspection - Oceaneering	07
Locating Stuck Pipeline PIG - Oceaneering	12
Inspection of Fire Proofed Structural Steel - Precision NDT	16
Shielding Testing for Healthcare Facilities - Aurora Health Physics	33

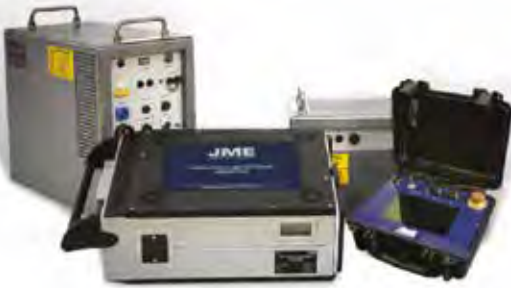
PXB:2.5

Dose Rate (Min)	0.7	R/Min (@1mtr)
Dose Rate (Average)	1	R/Min (@1mtr)
Energy Range	1 to 2.5	MeV
HVL Steel	20	mm
HVL Concrete	-	mm
Focal Spot	0.2 x 2	mm
Max. Penetration Steel	120	mm
Max. Penetration Concrete	500	mm

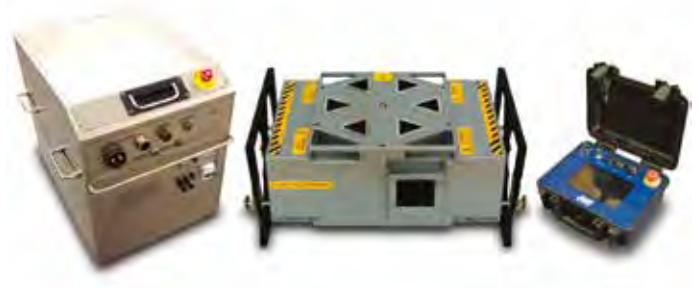
PXB:6

Dose Rate (Min)	3	R/Min (@1mtr)
Dose Rate (Average)	4	R/Min (@1mtr)
Energy Range	2 to 6	MeV
HVL Steel	28	mm
HVL Concrete	102	mm
Focal Spot	0.3 x 3	mm
Max. Penetration Steel	180	mm
Max. Penetration Concrete	750	mm

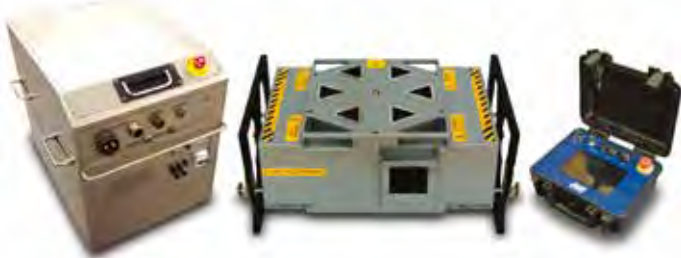
PXB:7.5

Dose Rate (Min)	5	R/Min (@1mtr)
Dose Rate (Average)	7	R/Min (@1mtr)
Energy Range	2 to 7.5	MeV
HVL Steel	32	mm
HVL Concrete	110	mm
Focal Spot	0.3 x 3	mm
Max. Penetration Steel	220	mm
Max. Penetration Concrete	1000	mm

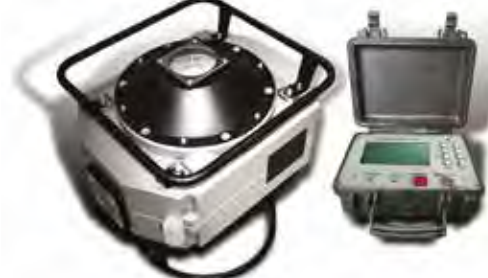
PXB:9

Dose Rate (Min)	15	R/Min (@1mtr)
Dose Rate (Average)	20	R/Min (@1mtr)
Energy Range	2 to 9	MeV
HVL Steel	35	mm
HVL Concrete	125	mm
Focal Spot	0.3 x 3	mm
Max. Penetration Steel	300	mm
Max. Penetration Concrete	1250	mm

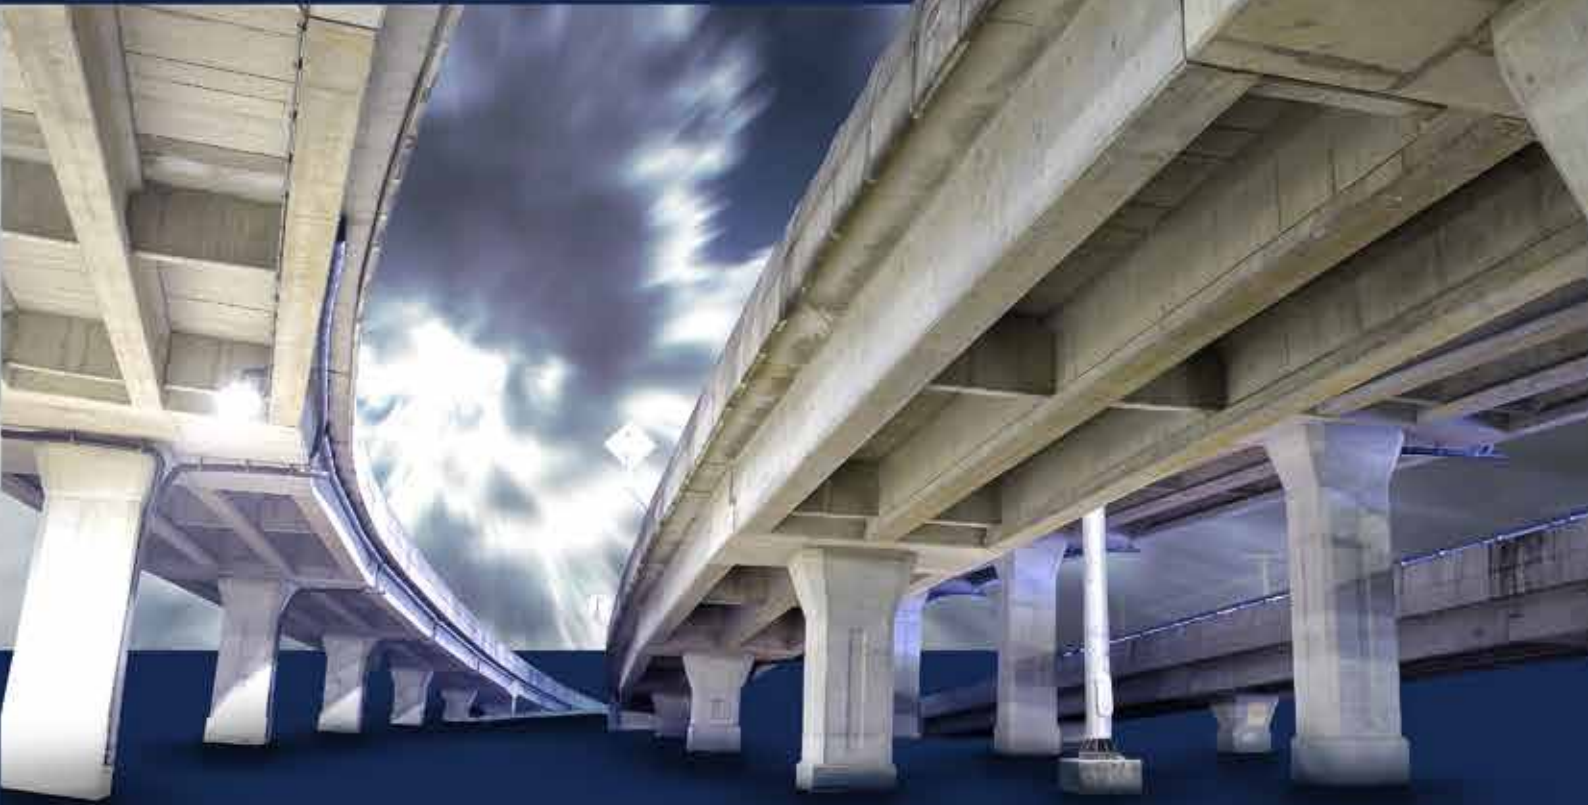
BRIDGE INSPECTION USING THE JME BETATRON SYSTEM

JME delivered their 7.5 MeV Portable Betatron system to a small village north of Rome, and supported the inspection company, alongside the digital panel supplier in successfully carrying out over 120 individual exposures on concrete thicknesses ranging from 300 – 1100 mm's. Using this system, the inspection company were able to evaluate, not only the presence of the steel cables within the concrete, but take accurate measurements of its

The portability of the Betatron system, coupled with its high energy output puts it in a position of being the only X-Ray source capable of performing this kind of inspection. Using an underbridge inspection platform, the Betatron system and digital panel were mounted in their specially designed fixtures and lowered into position under the bridge superstructure.

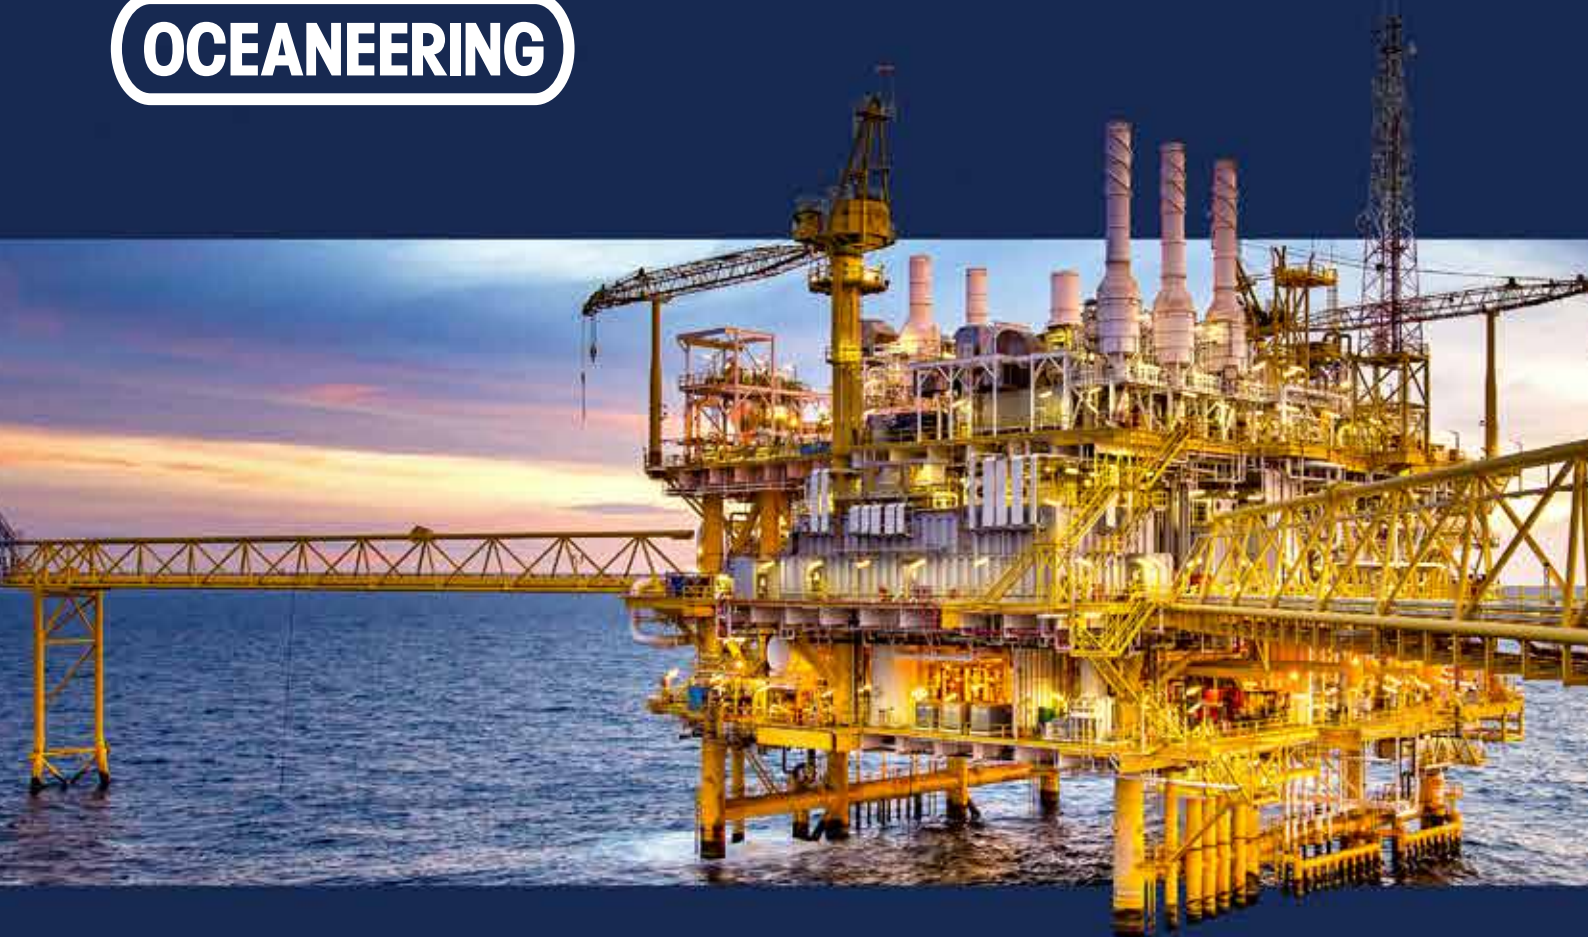
- BETATRON AND WIRELESS DIGITAL DETECTOR
- OFFSHORE THICK WALL RISERS
- EXTERNAL CORROSION ASSESSMENT

Oceaneering Inspection Solution Combines High-Energy X-Ray and Digital Detector Array to Confirm Fitness for Service on Large-Diameter, Heavy Wall Risers Solution safely delivers high-resolution images and corrosion measurement data in near real time on an offshore installation

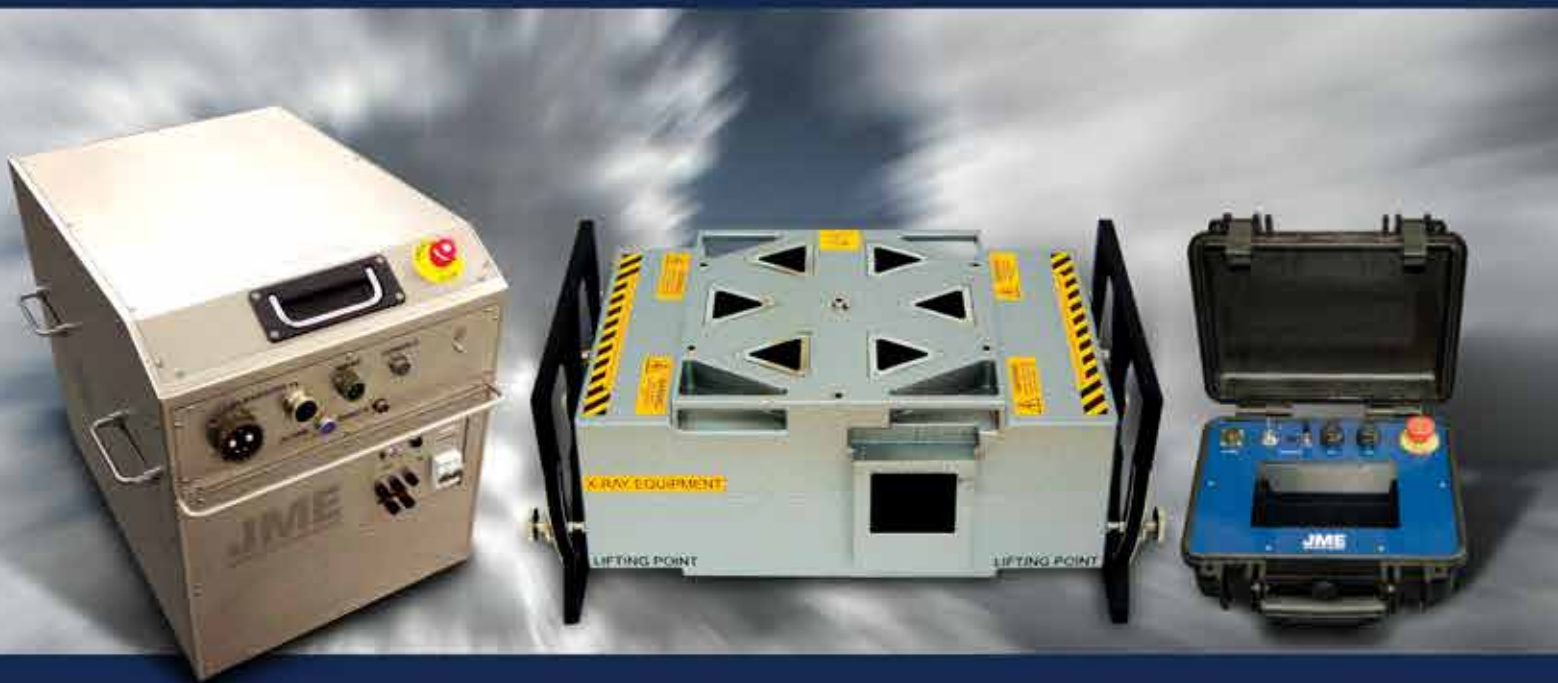
LOCATING STUCK PIPELINE PIG USING HIGH ENERGY X-RAYS AND DIGITAL RADIOGRAPHY DETECTOR

- JME PORTABLE X-RAY BETATRON 7.5MEV

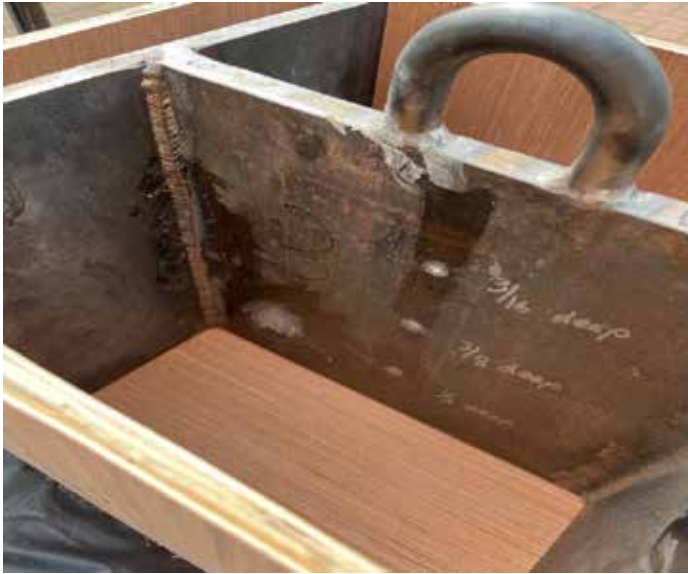
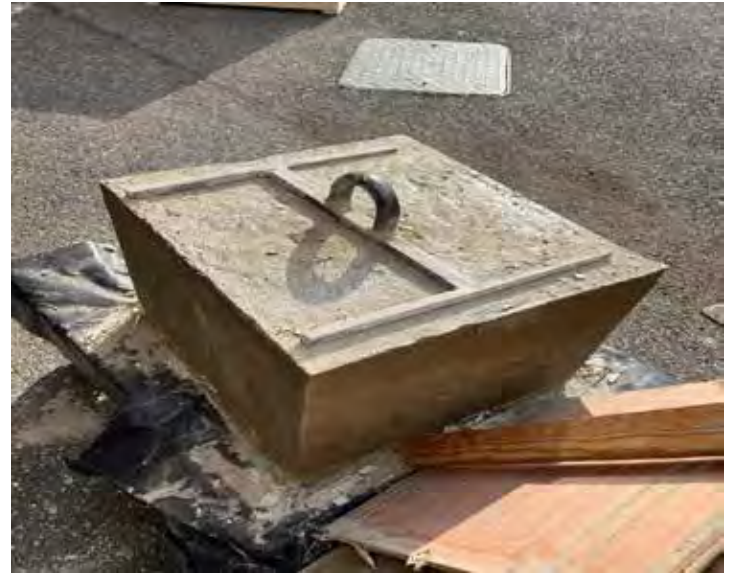
TECHNICAL SPECIFICATIONS

Accelerator (Radiator)	600 x 400 x 230	109kg
Power Unit	590 x 380 x 360	60kg
Control Panel	130 x 200 x 30	0.5kg

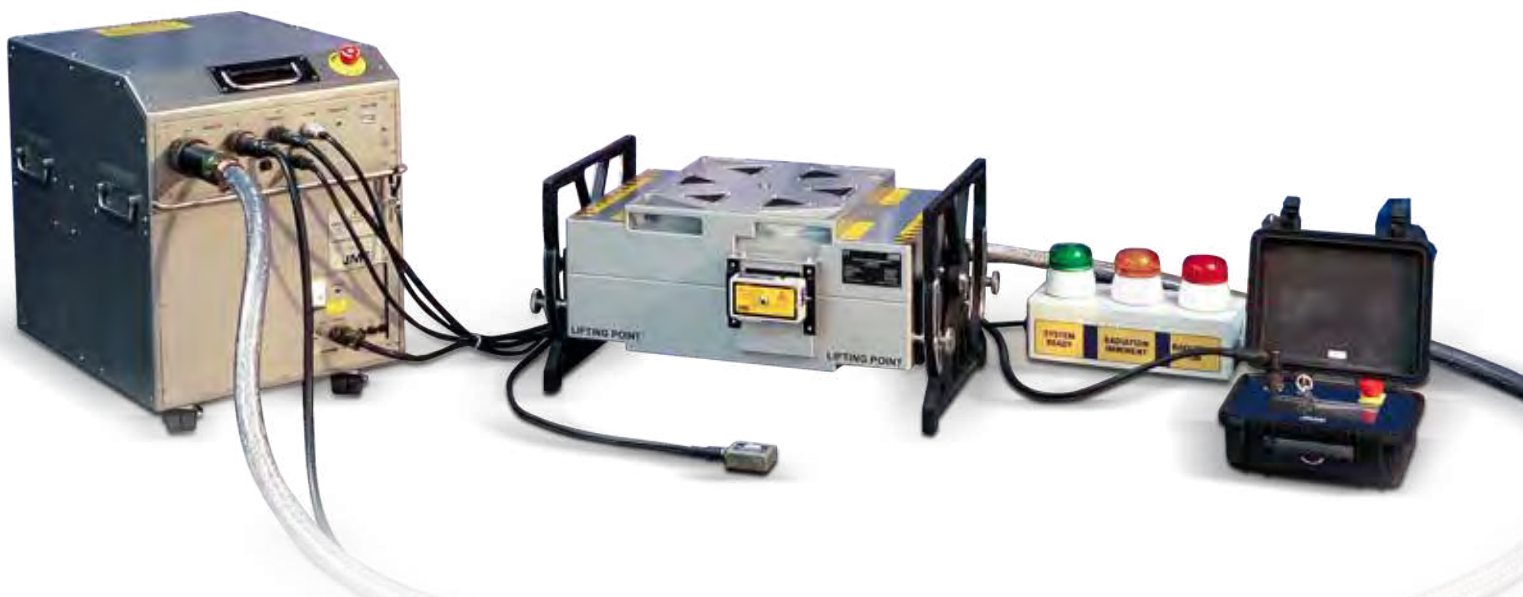
DIMENSIONS AND WEIGHT

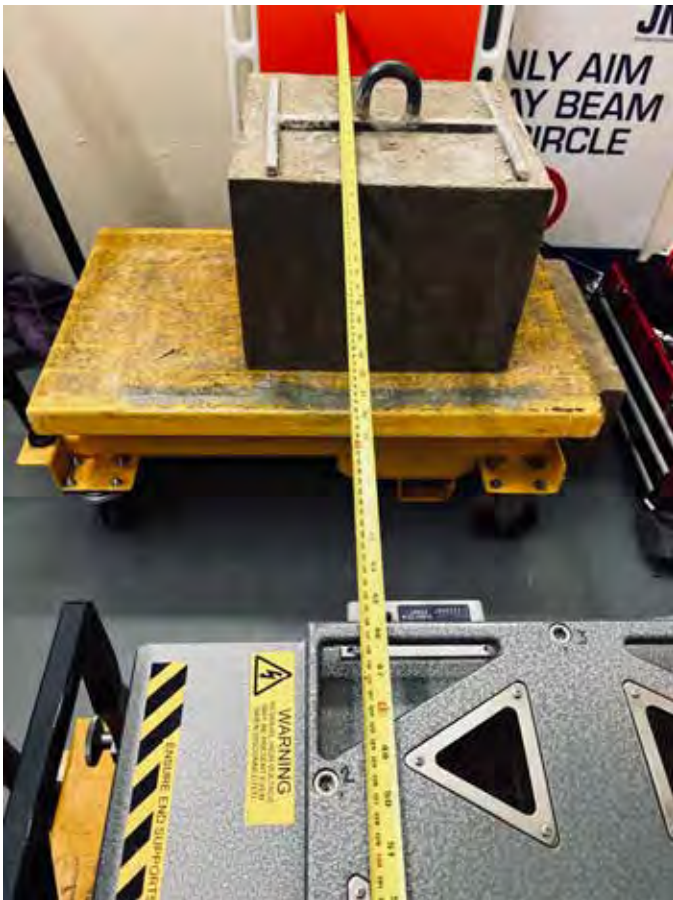
Source to Object Distance:	36"	Exposure in Seconds:	110
Source to Detector Distance:	53"	No. of Frames:	5
Object to Detector Distance:	17"	Megaelectron Volts (MeV):	2.5
Focal Spot:	.3mm x 3mm, .119"	Filters Applied:	Edge DR 1

Comments: 2.5 MeV proved to penetrate the specimen at 110 seconds/frame. The 1/2t and 3/4t holes were visible; however, the excessive exposure time and inability to pull the 1/4t hole was unfavorable. It was decided to increase the exposure time to deliver more dose to the plate.

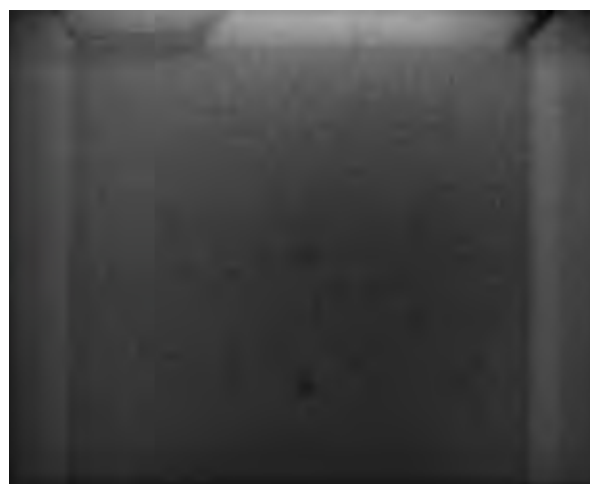
Source to Object Distance:	45"	Exposure in Seconds:	115
Source to Detector Distance:	53"	No. of Frames:	5
Object to Detector Distance:	8"	Megaelectron Volts (MeV):	2.5
Focal Spot:	.3mm x 3mm, .119" .119" Diagonal	Filters Applied:	Edge DR 1

Comments: Test 3 proved favorable with added definition and sharpness to the 1/4t hole; however, the exposure time was still not desired. It was decided to increase the MeV, decrease the source to object and decrease the time.

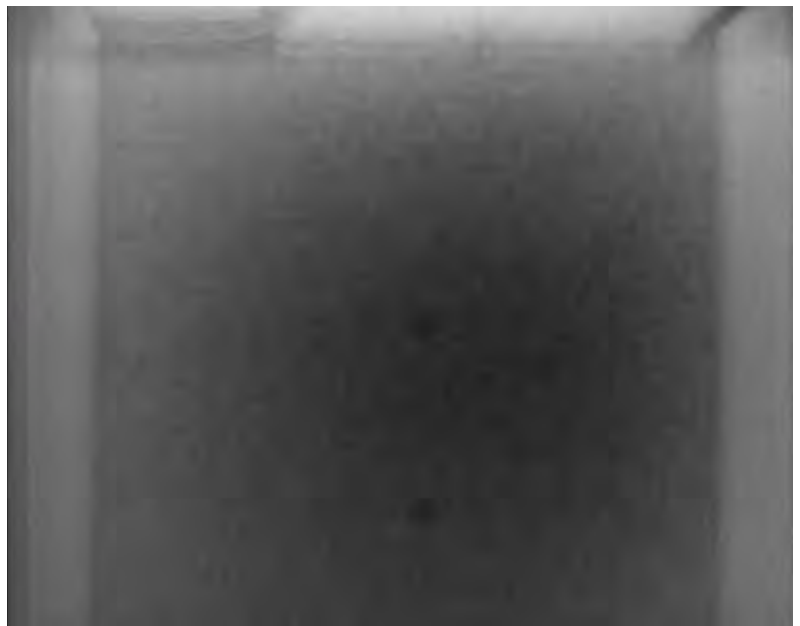
Source to Object Distance:	30"	Exposure in Seconds:	90
Source to Detector Distance:	38"	No. of Frames:	5
Object to Detector Distance:	9"	Megaelectron Volts (MeV):	5.0
Focal Spot:	.3mm x 3mm, .119"	Filters Applied:	Edge DR 1

Commentary: Test 4 provided optimal definition and sensitivity, less mottling of the image was realized, which gave the precedence to increase the MeV to the maximum output of the tube and achieve 100% efficiency. It is deduced that the reduction in mottling is due to the decrease in wavelength as a result of the MeV increase.

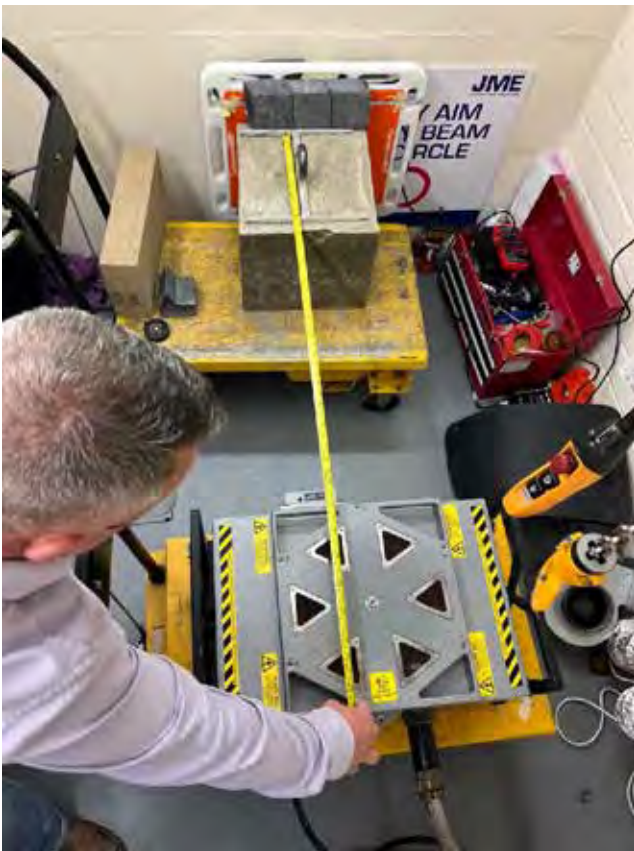
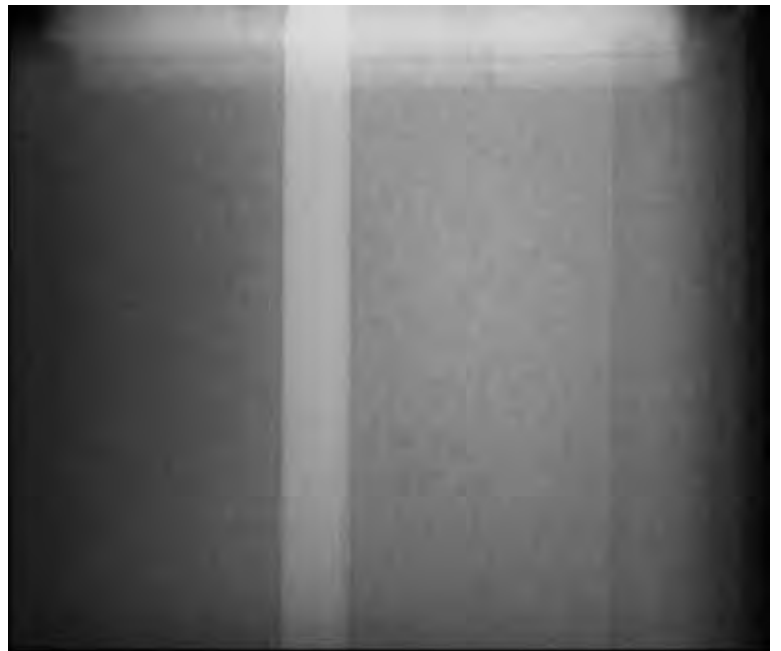
Source to Object Distance:	45"	Exposure in Seconds:	40
Source to Detector Distance:	53"	No. of Frames:	5
Object to Detector Distance:	8"	Megaelectron Volts (MeV):	7.5
Focal Spot:	.3mm x 3mm, .119" Diagonal	Filters Applied:	Edge DR 1
Notes:	Rotated 90 degrees

Comments: Although we do not intend to expose the specimen through the thicker cross section, it was decided to attempt one of these images. You will notice that on the bottom right-hand portion of the web of the I-beam there is a noticeable loss of material, this material loss is from a gouge (2.07 mm) ground into the web on the source side of the I-beam. This is a phenomenal revelation given that this discontinuity is being revealed through 13" of steel and is not noticeable through 13.250" of concrete and 3/4" of steel. This is a real testament of the penetrating power of the accelerator and the scatter interruption when shooting through concrete.

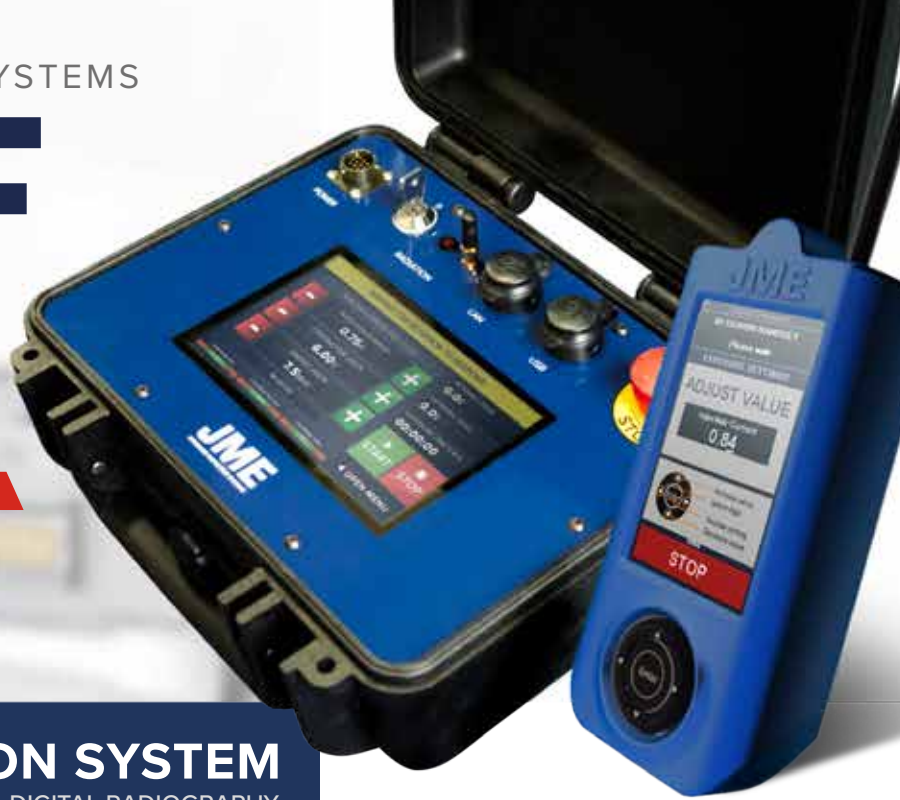
PXB:RF

CONTROL PANEL + REMOTE HANDSET
