NDT CASE STUDY

DXB RTR  
PIPELINE RADIOGRAPHY  
NATIONAL INSPECTION SERVICES

DXB:1  
DIGITAL X-RAY BUGGY

### PROJECT OVERVIEW

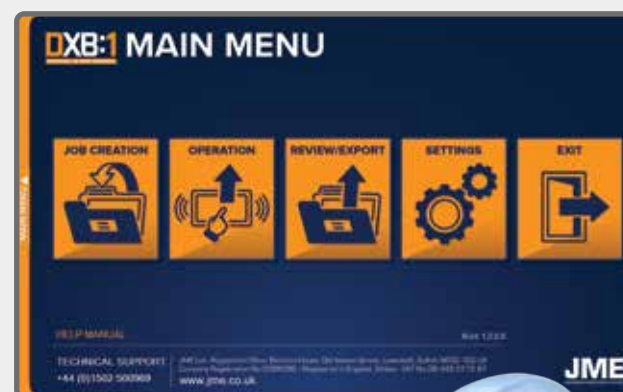
DXB CONTROL TABLET USER INTERFACE

The DXB Software Suite allows for real-time X-Ray image acquisition, along with viewing, image processing and archiving of images. The Pipeline Crawler and X-Ray source settings can be controlled directly from within the software without the need for other control devices. X-Ray images are stored in DICONDE data format and saved to the current project, along with any additional photographs, notes, inspection date, time and GPS co-ordinates. Using the JME stitching algorithm, a single image can be viewed in real-time, with the full weld stitched upon completion of the weld acquisition.
